## Characteristics of Decorative Wooden Flooring in the Castle Museum in Łańcut

**Abstract:** *Characteristics of Decorative Wooden Flooring in the Castle Museum in Łańcut.* The paper presents an analysis of research on decorative wooden flooring in the Castle Museum in Łańcut. It focuses on the characteristics of design, structure and the wood species used, paying attention to their anatomic features and the state of flooring preservation. Taking into account the size of the site and the modifications of interiors that took place at different moments in time, all the features under investigation proved to be very diversified.

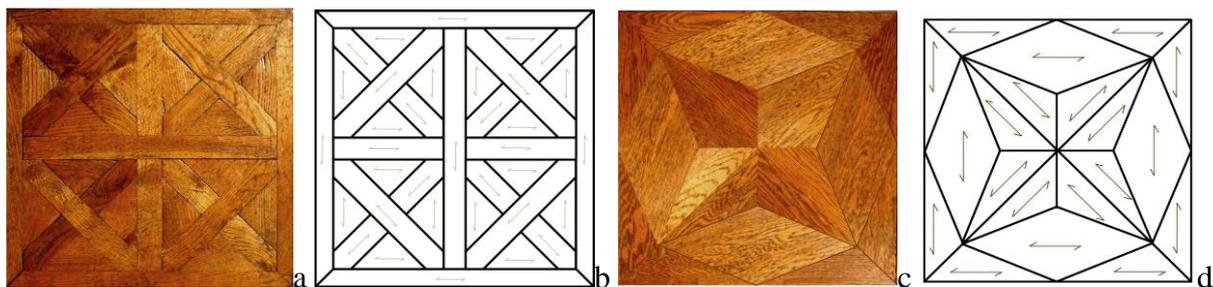
Fig. 1. Tile from the Master's Study (a - tile view, b - pattern and fibre direction) and from the Salon of the State Apartment (c - tile view, d - pattern and fibre direction).

The tile design may be quite simple – geometrical, using just one (Fig. 1) or a couple of wood species (Fig. 2-5) or quite complex - based on stylized plant motifs.

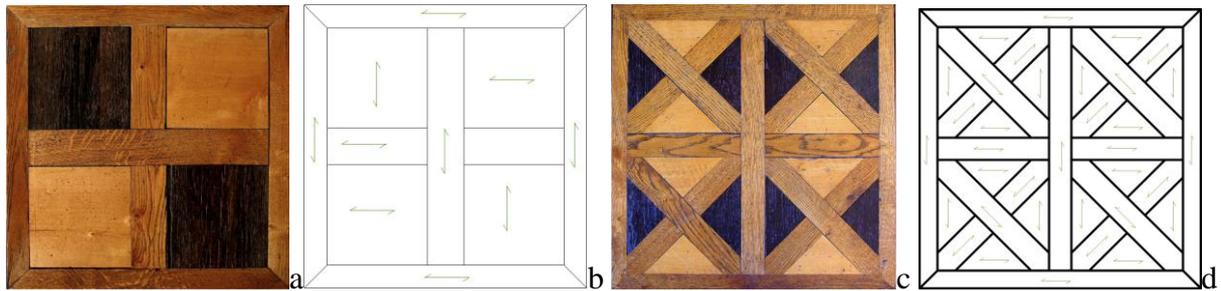
Fig. 2. Tile from the Sculpture Gallery (a - tile view, b - pattern and fibre direction) and the Chapel (c - tile view, d - pattern and fibre direction).

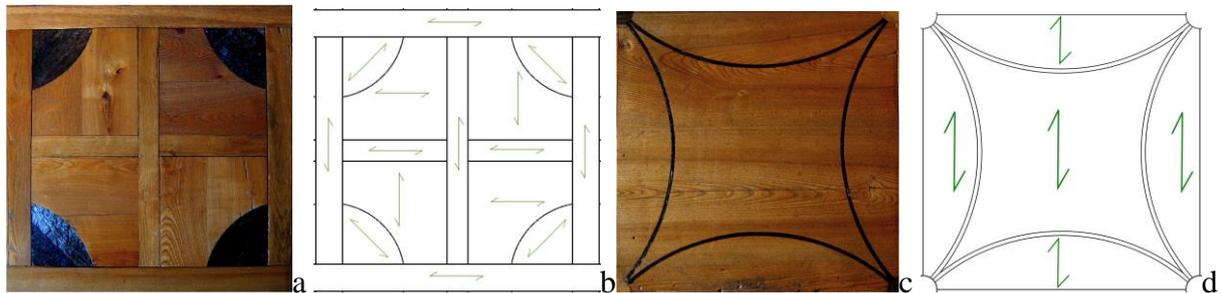
Fig. 3. Tile from the Entrance Salon (a - tile view, b - pattern and fibre direction) and the Bachelor's Apartment (c - tile view, d - pattern and fibre direction).

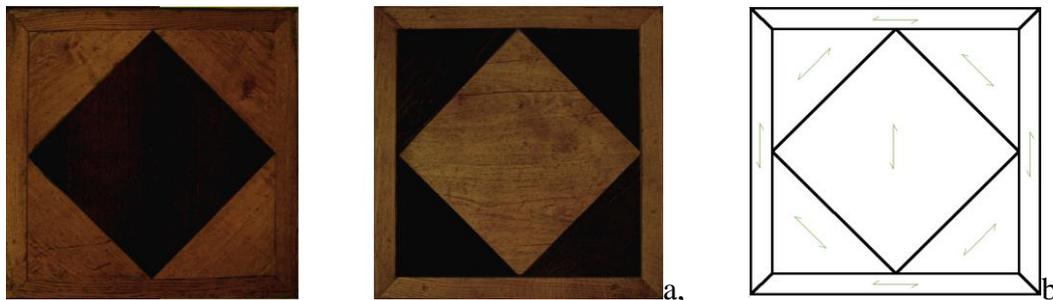
Fig. 4. Tile from the Bathroom of the State Apartment (a - tile view, b - tile design and fibre direction).

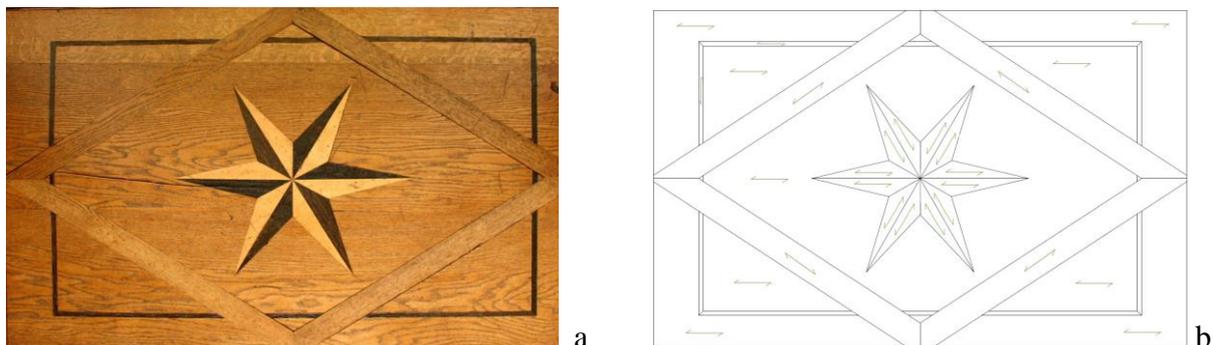
Fig. 5. Tile from the Ball Room (a - tile view, b - design and fibre direction).

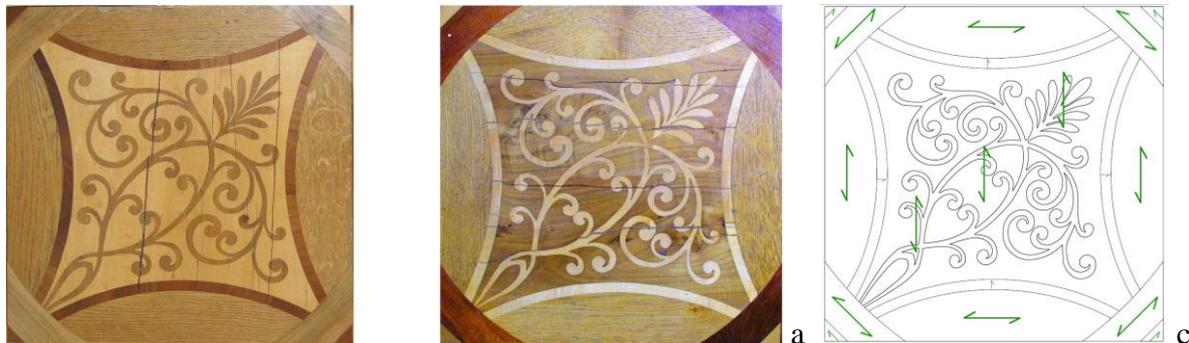
In nine cases, the tiles have their pairs that repeat the pattern, yet the wood species are inverted (Fig. 6, 7 and 8). This solution is used in furniture making for the Boulle inlays. These were made by cutting the pattern at the same time in two (or more) boards of different

wood species or other materials and then interchanging the background and pattern elements. The reversed tiles are used for decorative purposes in one of the rooms in a chessboard layout (Ladies' Bedroom) or for the decoration of two rooms in an inverted colour pattern (e.g. the Rococo Salon and the Columned Salon).

Fig. 6. Tile from the Boucher Room and the Corner Salon (a - tile view, b - design and fibre direction).

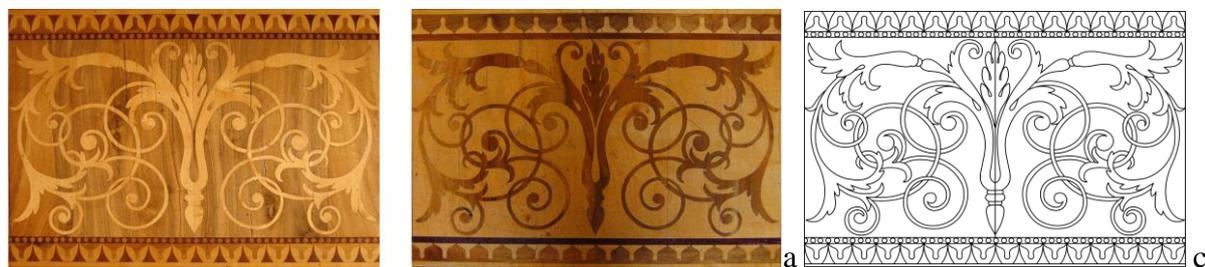
Fig. 7. Tile from the Rococo Salon the Columned Salon (a - tile view, b - design and fibre direction).

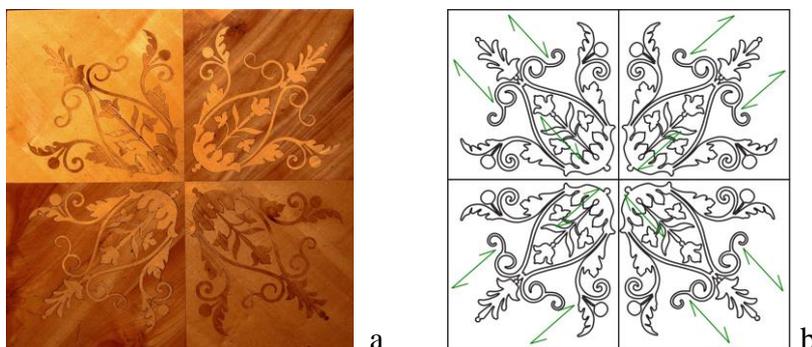
Fig. 8. Tile from the Ladies' Bedroom (a - tile view, b - design and fibre direction).

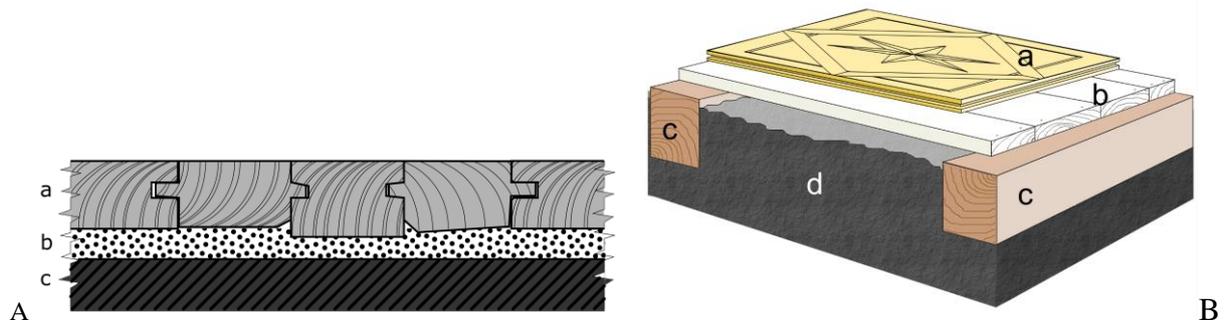
In some of the rooms, the bottom surface of the flooring is uneven; therefore it is necessary to apply sand as base (Fig. 9A). In other interiors, the tiles are installed on a blind floor, which provides them with a lot more stability (Fig. 9B).

Fig. 9. Manner of flooring installation in the Chapel (A: a – tile, b – sand, c - concrete) and the manner of flooring installation in the Ball Room (B: a – tile, b – boarding, c - ceiling beams, d – sand)

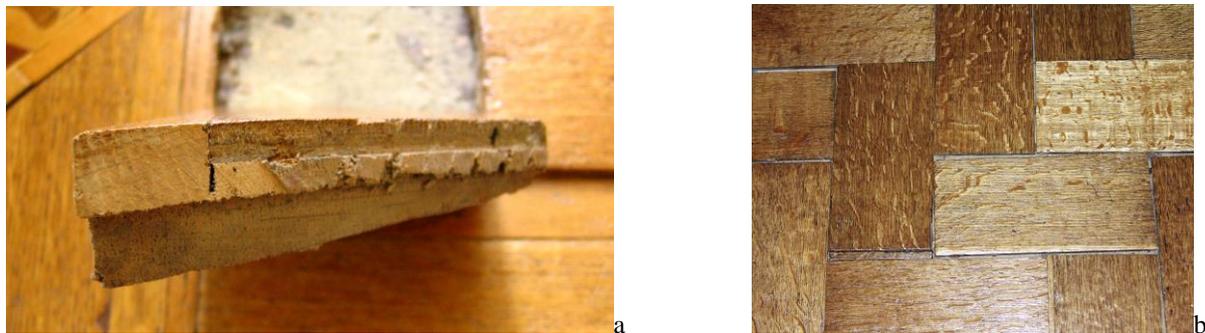
The oak parquet in the rooms on the first floor has different dimensions in each of the rooms, being about 220-295 mm long and 110-147 mm wide. All the planks have a uniform section – radial. On the bottom side the planks are only rough-hewn and the differences in their thickness are quite considerable (Fig. 10a), both between the individual planks, as within one single plank, and their dimensions range between 12 mm and 35 mm.

Fig. 10. Example of a plank from the Rococo Salon showing the difference in thickness and the gaps that appeared as a result of wood shrinkage and an example of their compensation with wooden battens.

In most of the parquets, gaps appeared as a result of shrinkage of the drying wood; sometimes they are filled with wooden battens (Fig. 11b).
